8 APRIL 2020

**PRELIMINARY SATELLITE-DERIVED DAMAGE ASSESSMENT  
SANMA AND MALAMPA PROVINCES, VANUATU**

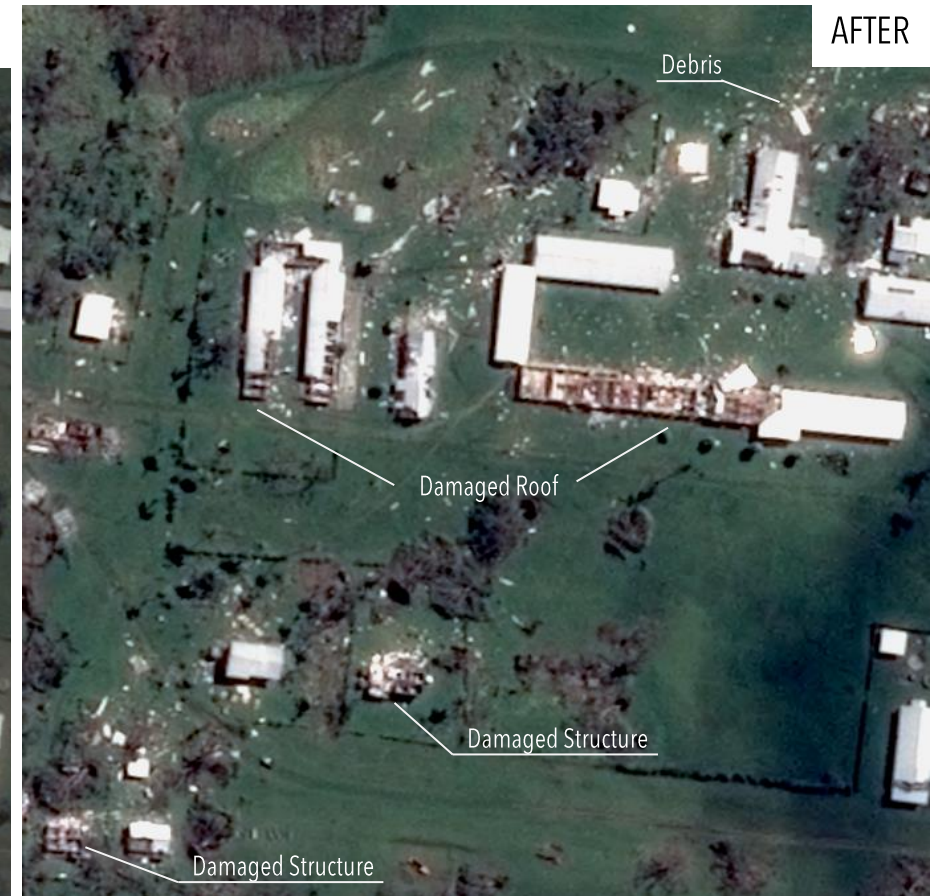
## AOI 1 LUGANVILLE MUNICIPALITY, SANMA PROVINCE, VANUATU : DAMAGED STRUCTURES

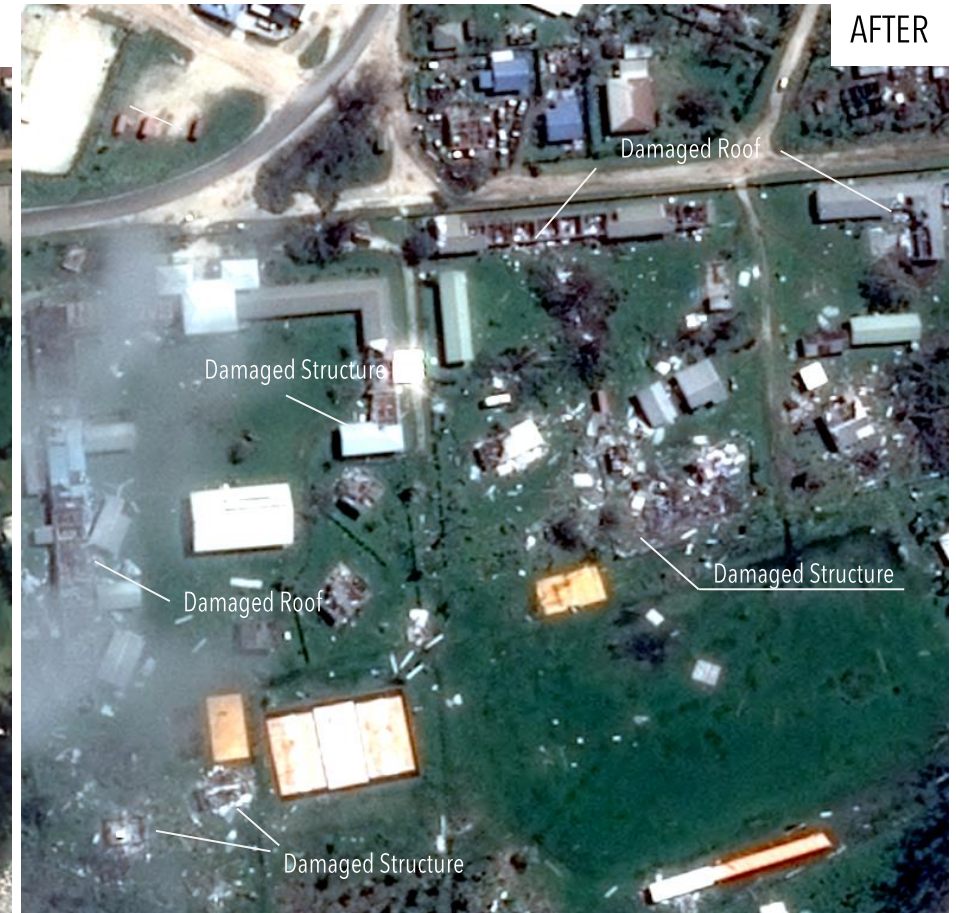
## AOI 1 LUGANVILLE MUNICIPALITY, SANMA PROVINCE, VANUATU : DAMAGED STRUCTURES

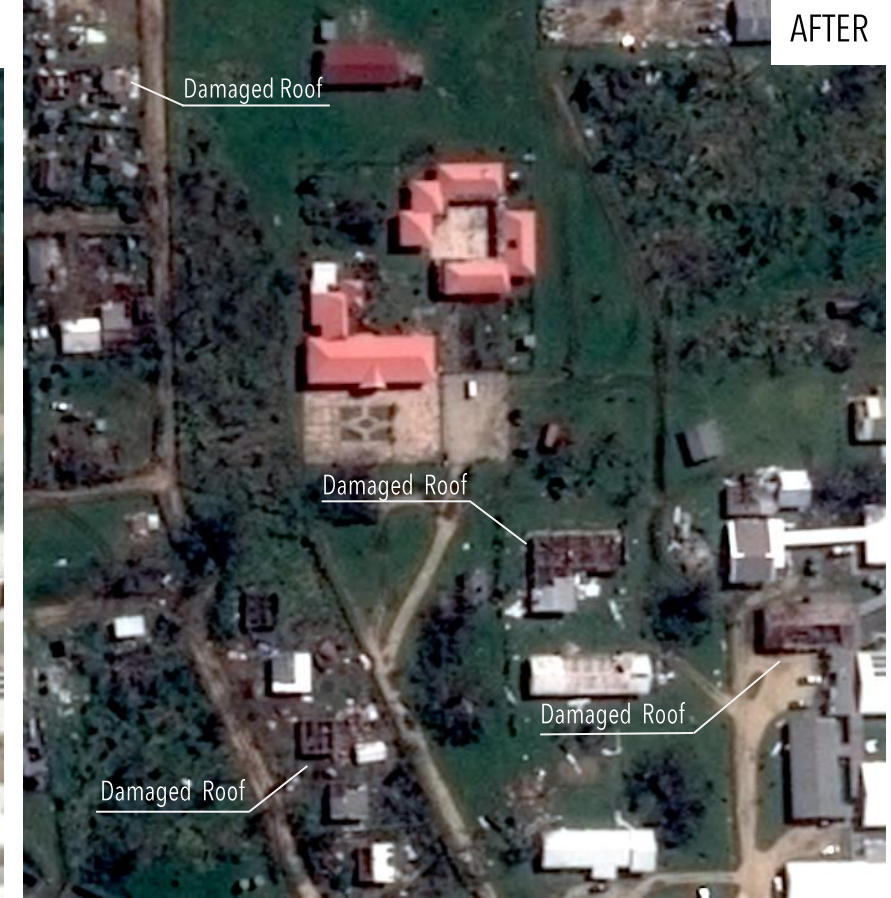
## AOI 1 LUGANVILLE MUNICIPALITY, SANMA PROVINCE, VANUATU : DAMAGED STRUCTURES

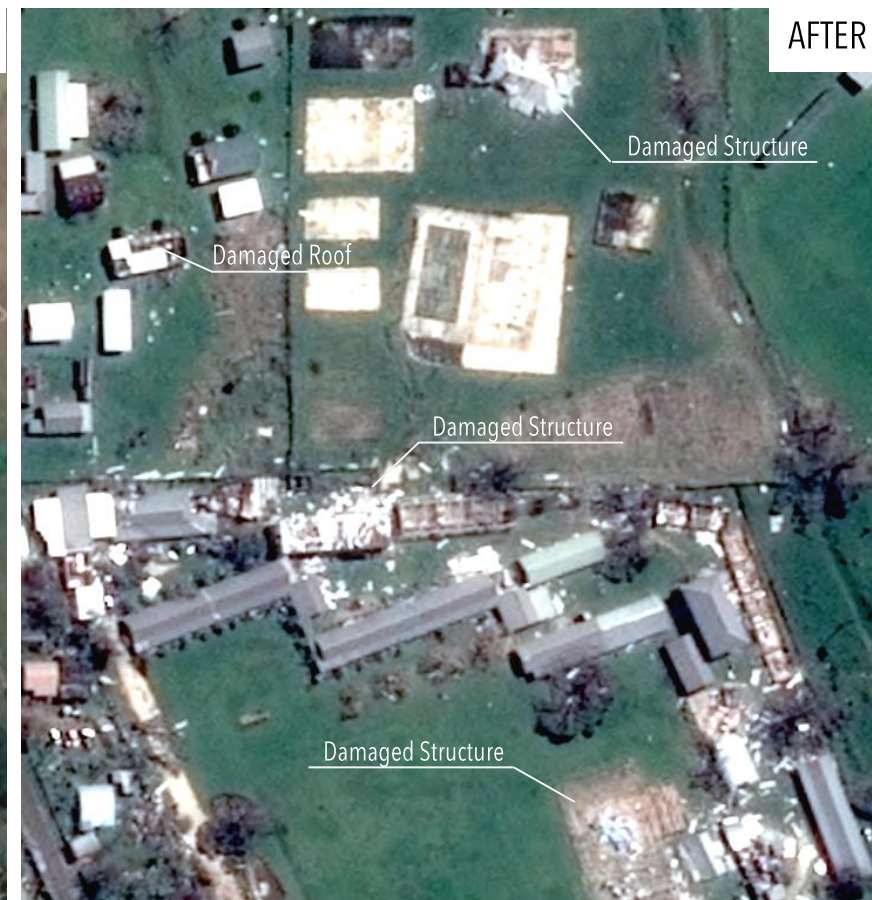
## AOI 1 LUGANVILLE MUNICIPALITY, SANMA PROVINCE, VANUATU : DAMAGED STRUCTURES

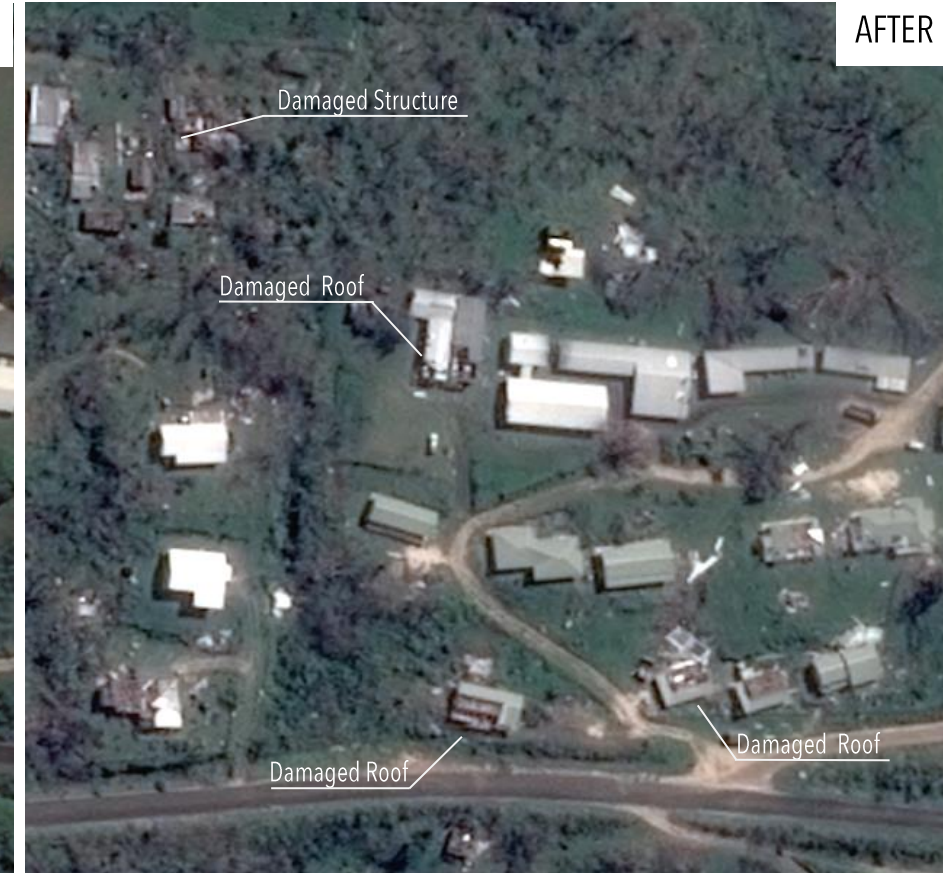
## AOI 1 LUGANVILLE MUNICIPALITY, SANMA PROVINCE, VANUATU : DAMAGED STRUCTURES

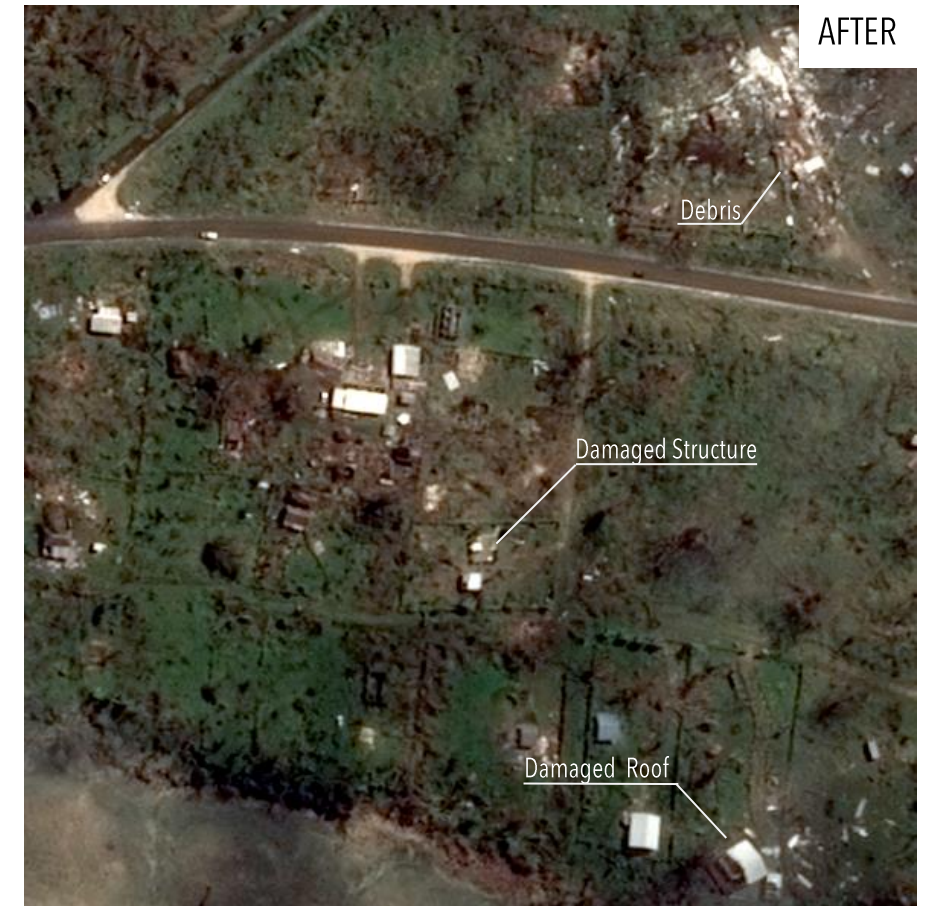
## AOI 1 LUGANVILLE MUNICIPALITY, SANMA PROVINCE, VANUATU : DAMAGED STRUCTURES

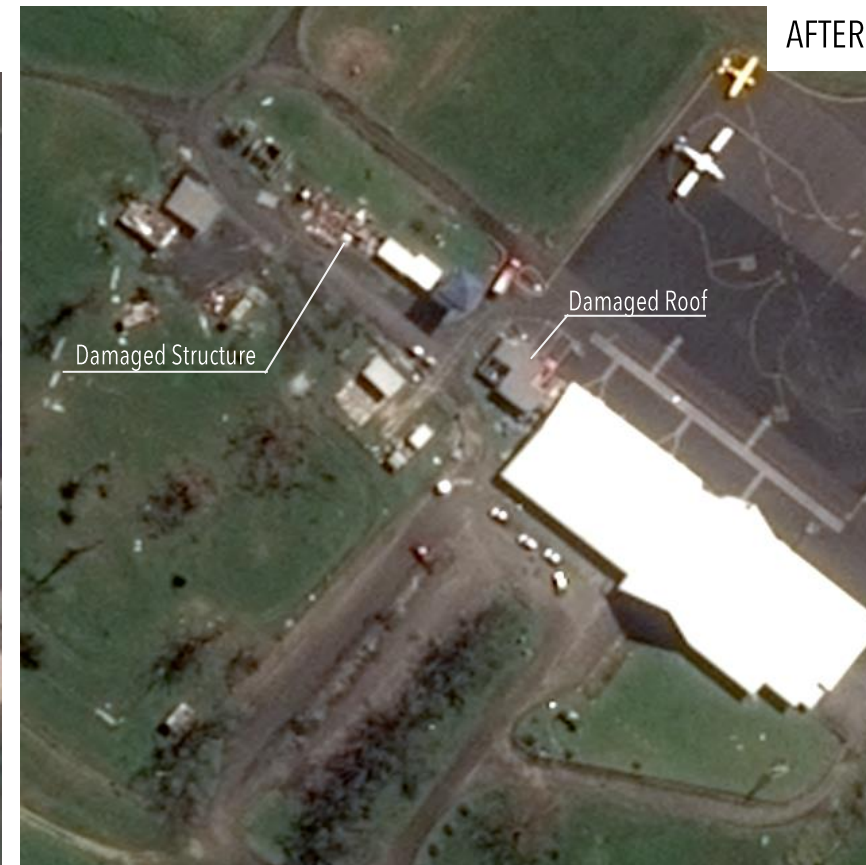
## AOI 1 LUGANVILLE MUNICIPALITY, SANMA PROVINCE, VANUATU : DAMAGED STRUCTURES

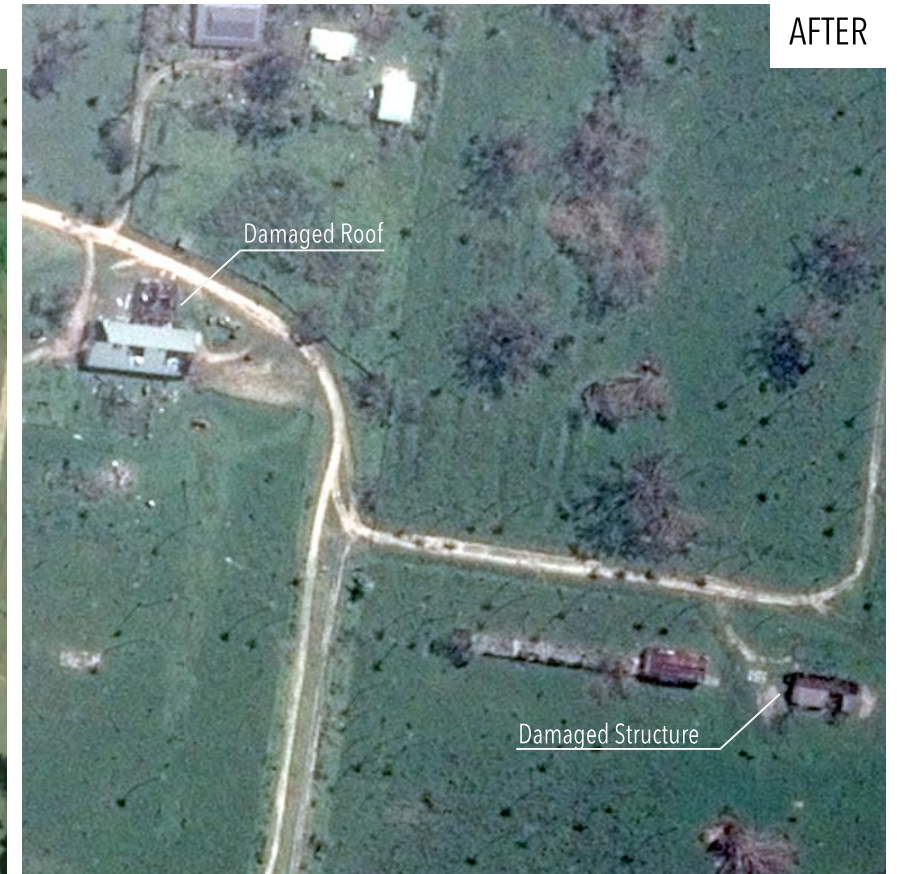
## AOI 1 LUGANVILLE MUNICIPALITY, SANMA PROVINCE, VANUATU : DAMAGED STRUCTURES

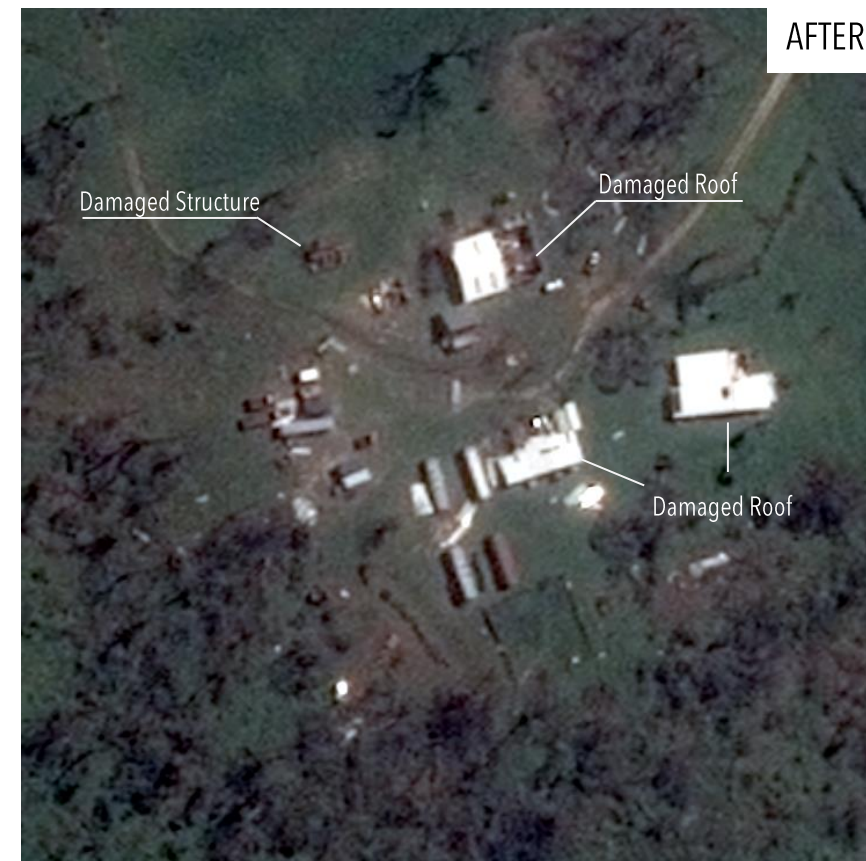
## AOI 1 LUGANVILLE MUNICIPALITY, SANMA PROVINCE, VANUATU : DAMAGED STRUCTURES

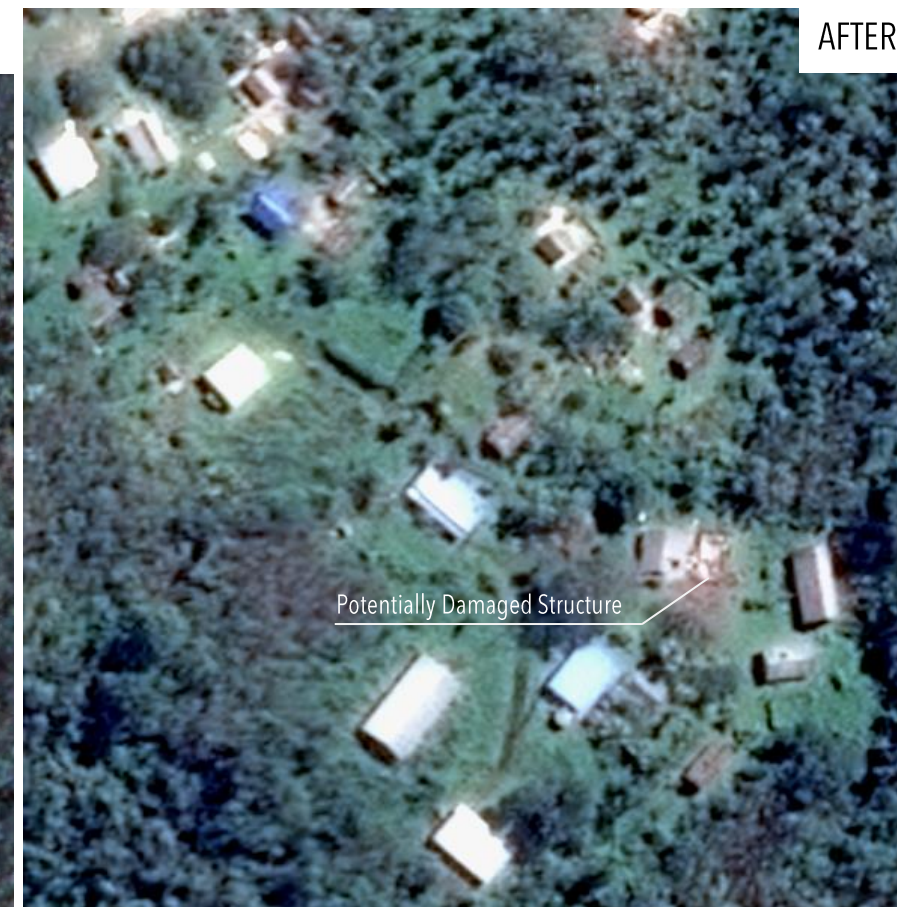
## AOI 2 NORTH WEST MALEKULA MUNICIPALITY, MALAMPA PROVINCE, VANUATU : POTENTIALLY DAMAGED STRUCTURES
