Production Date: 5/1/2014  
Version 1.0  
Activation Number: FL20140430AFG

## FLOODING AND IDPS IN KWANJANDUKO, JOWZJAN PROVINCE, AFGHANISTAN

Analysis using imagery collected 29 April 2014

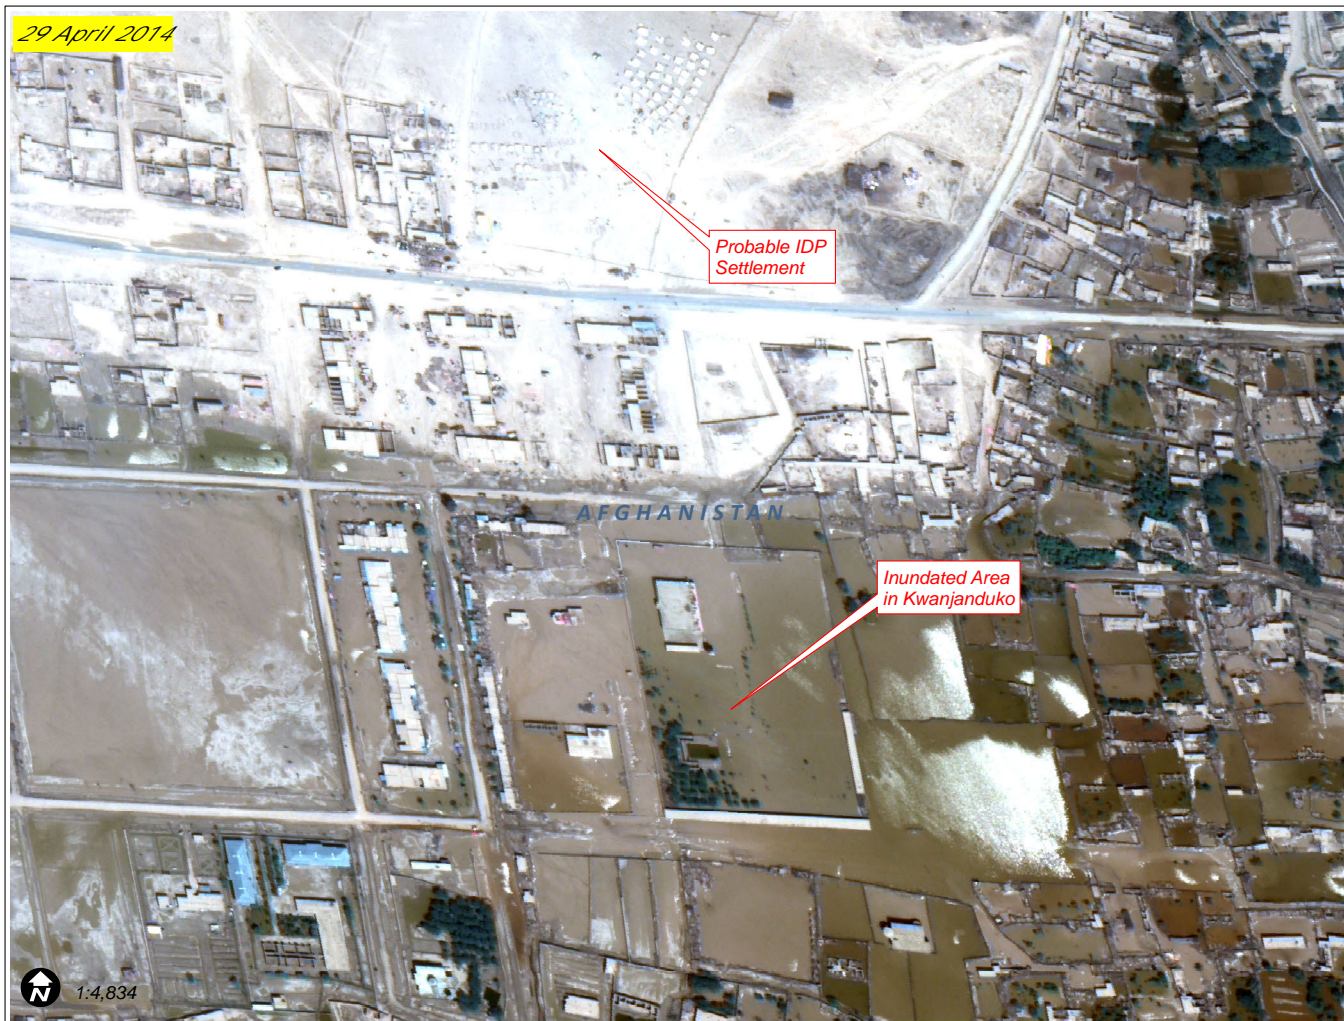
This image shows the center area of Kwanjanduko (Khvajeh do Kuh) inundated by flood waters as of 29 April 2014 (see Figure 1 for comparison image). A probable IDP settlement is also visible to the north.

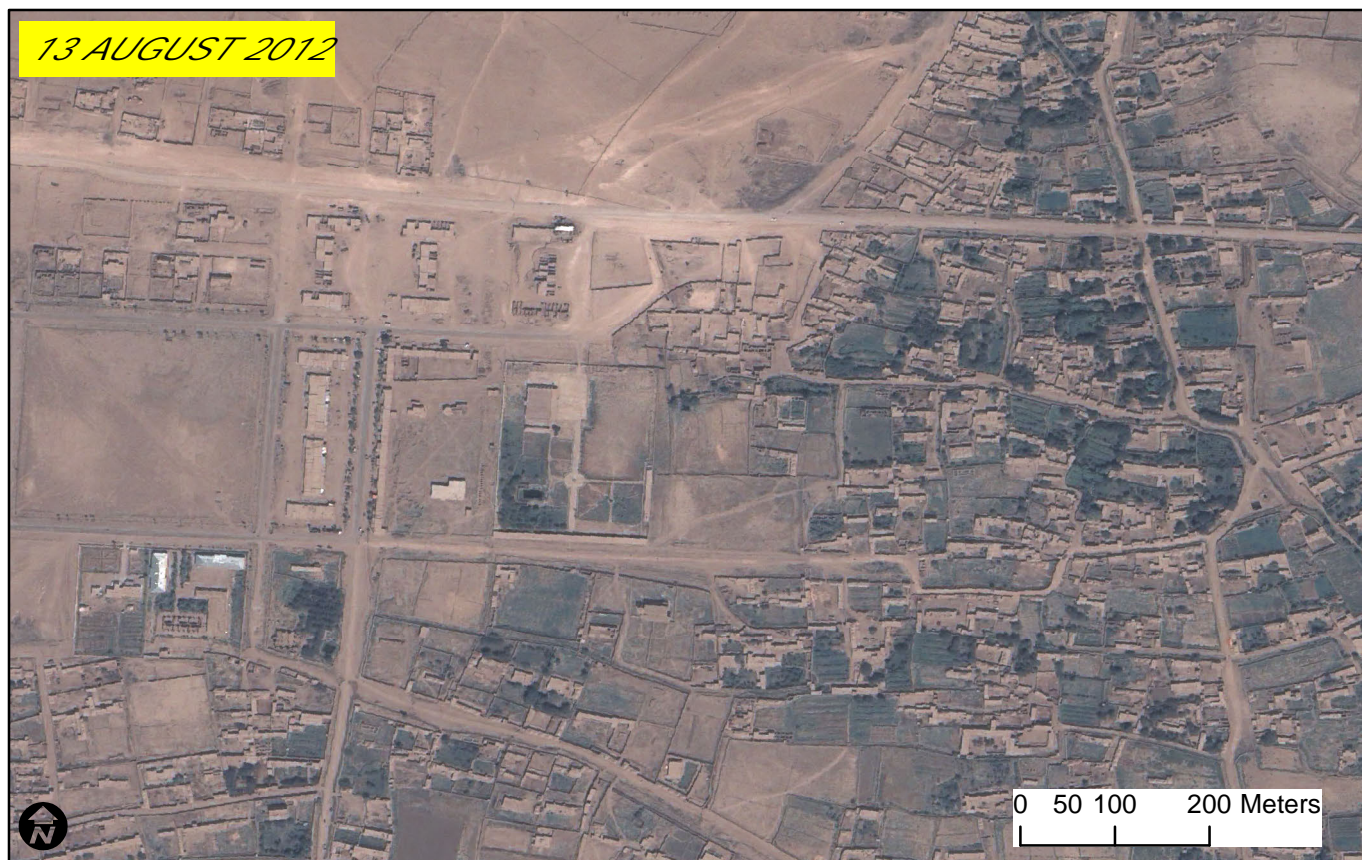
*Figure 1: Kwanjanduko Flood Waters and IDP Settlement*

The central area of Kwanjanduko (Khvajeh do Kuh) on 29 April 2014 shows multiple areas of standing flood waters (blue arrows) and a probable IDP encampment (red arrows). Surrounding countryside indicates additional standing waters, widespread inundated soils, some washed out roads, and significant damage to agricultural lands.
