EMSR703 - AOI01
Tropical Cyclone in Mexico
ACAPULCO COAST

Situation as of 28/10/2023 17:23 UTC
Grading MONIT01 - Overview map 01

Event:
On 25 October around 06:25 UTC, TC OTIS (Cat. 5 Hurricane) made landfall over the area of the coastal City of Acapulco (central Guerrero State, southern Mexico) with maximum sustained winds of 270 km/h OTIS-23.

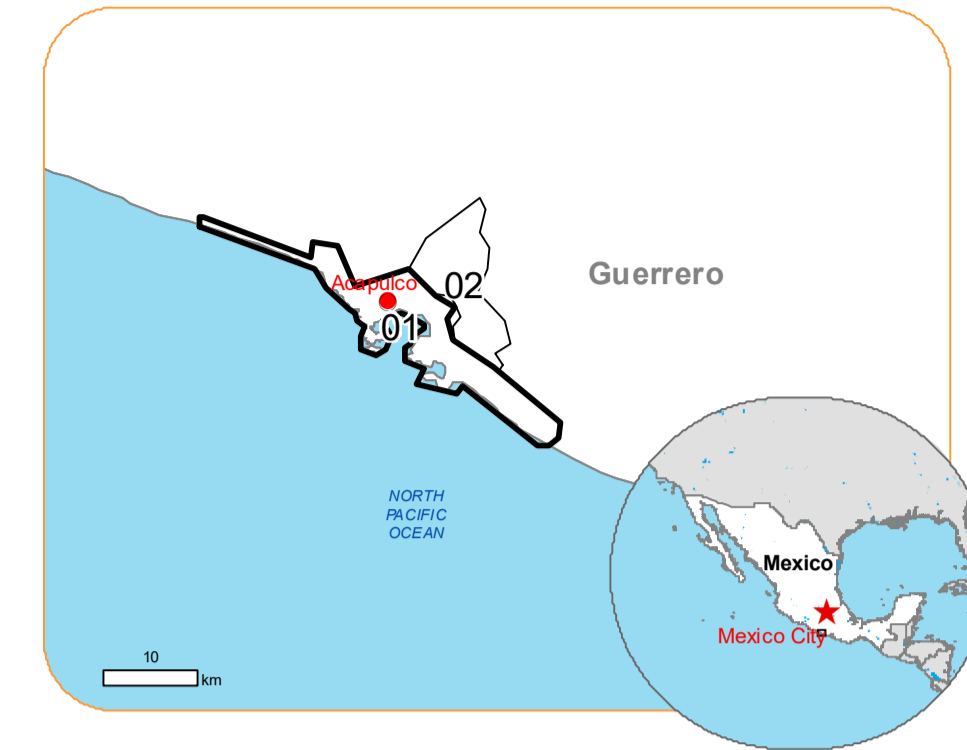
Flooded area 589.1 ha
Landslide 11.4 ha
Potentially affected population ~ 380,000

Road 28.1 km
Bridge 8 No.
Built-up 4750.2 ha

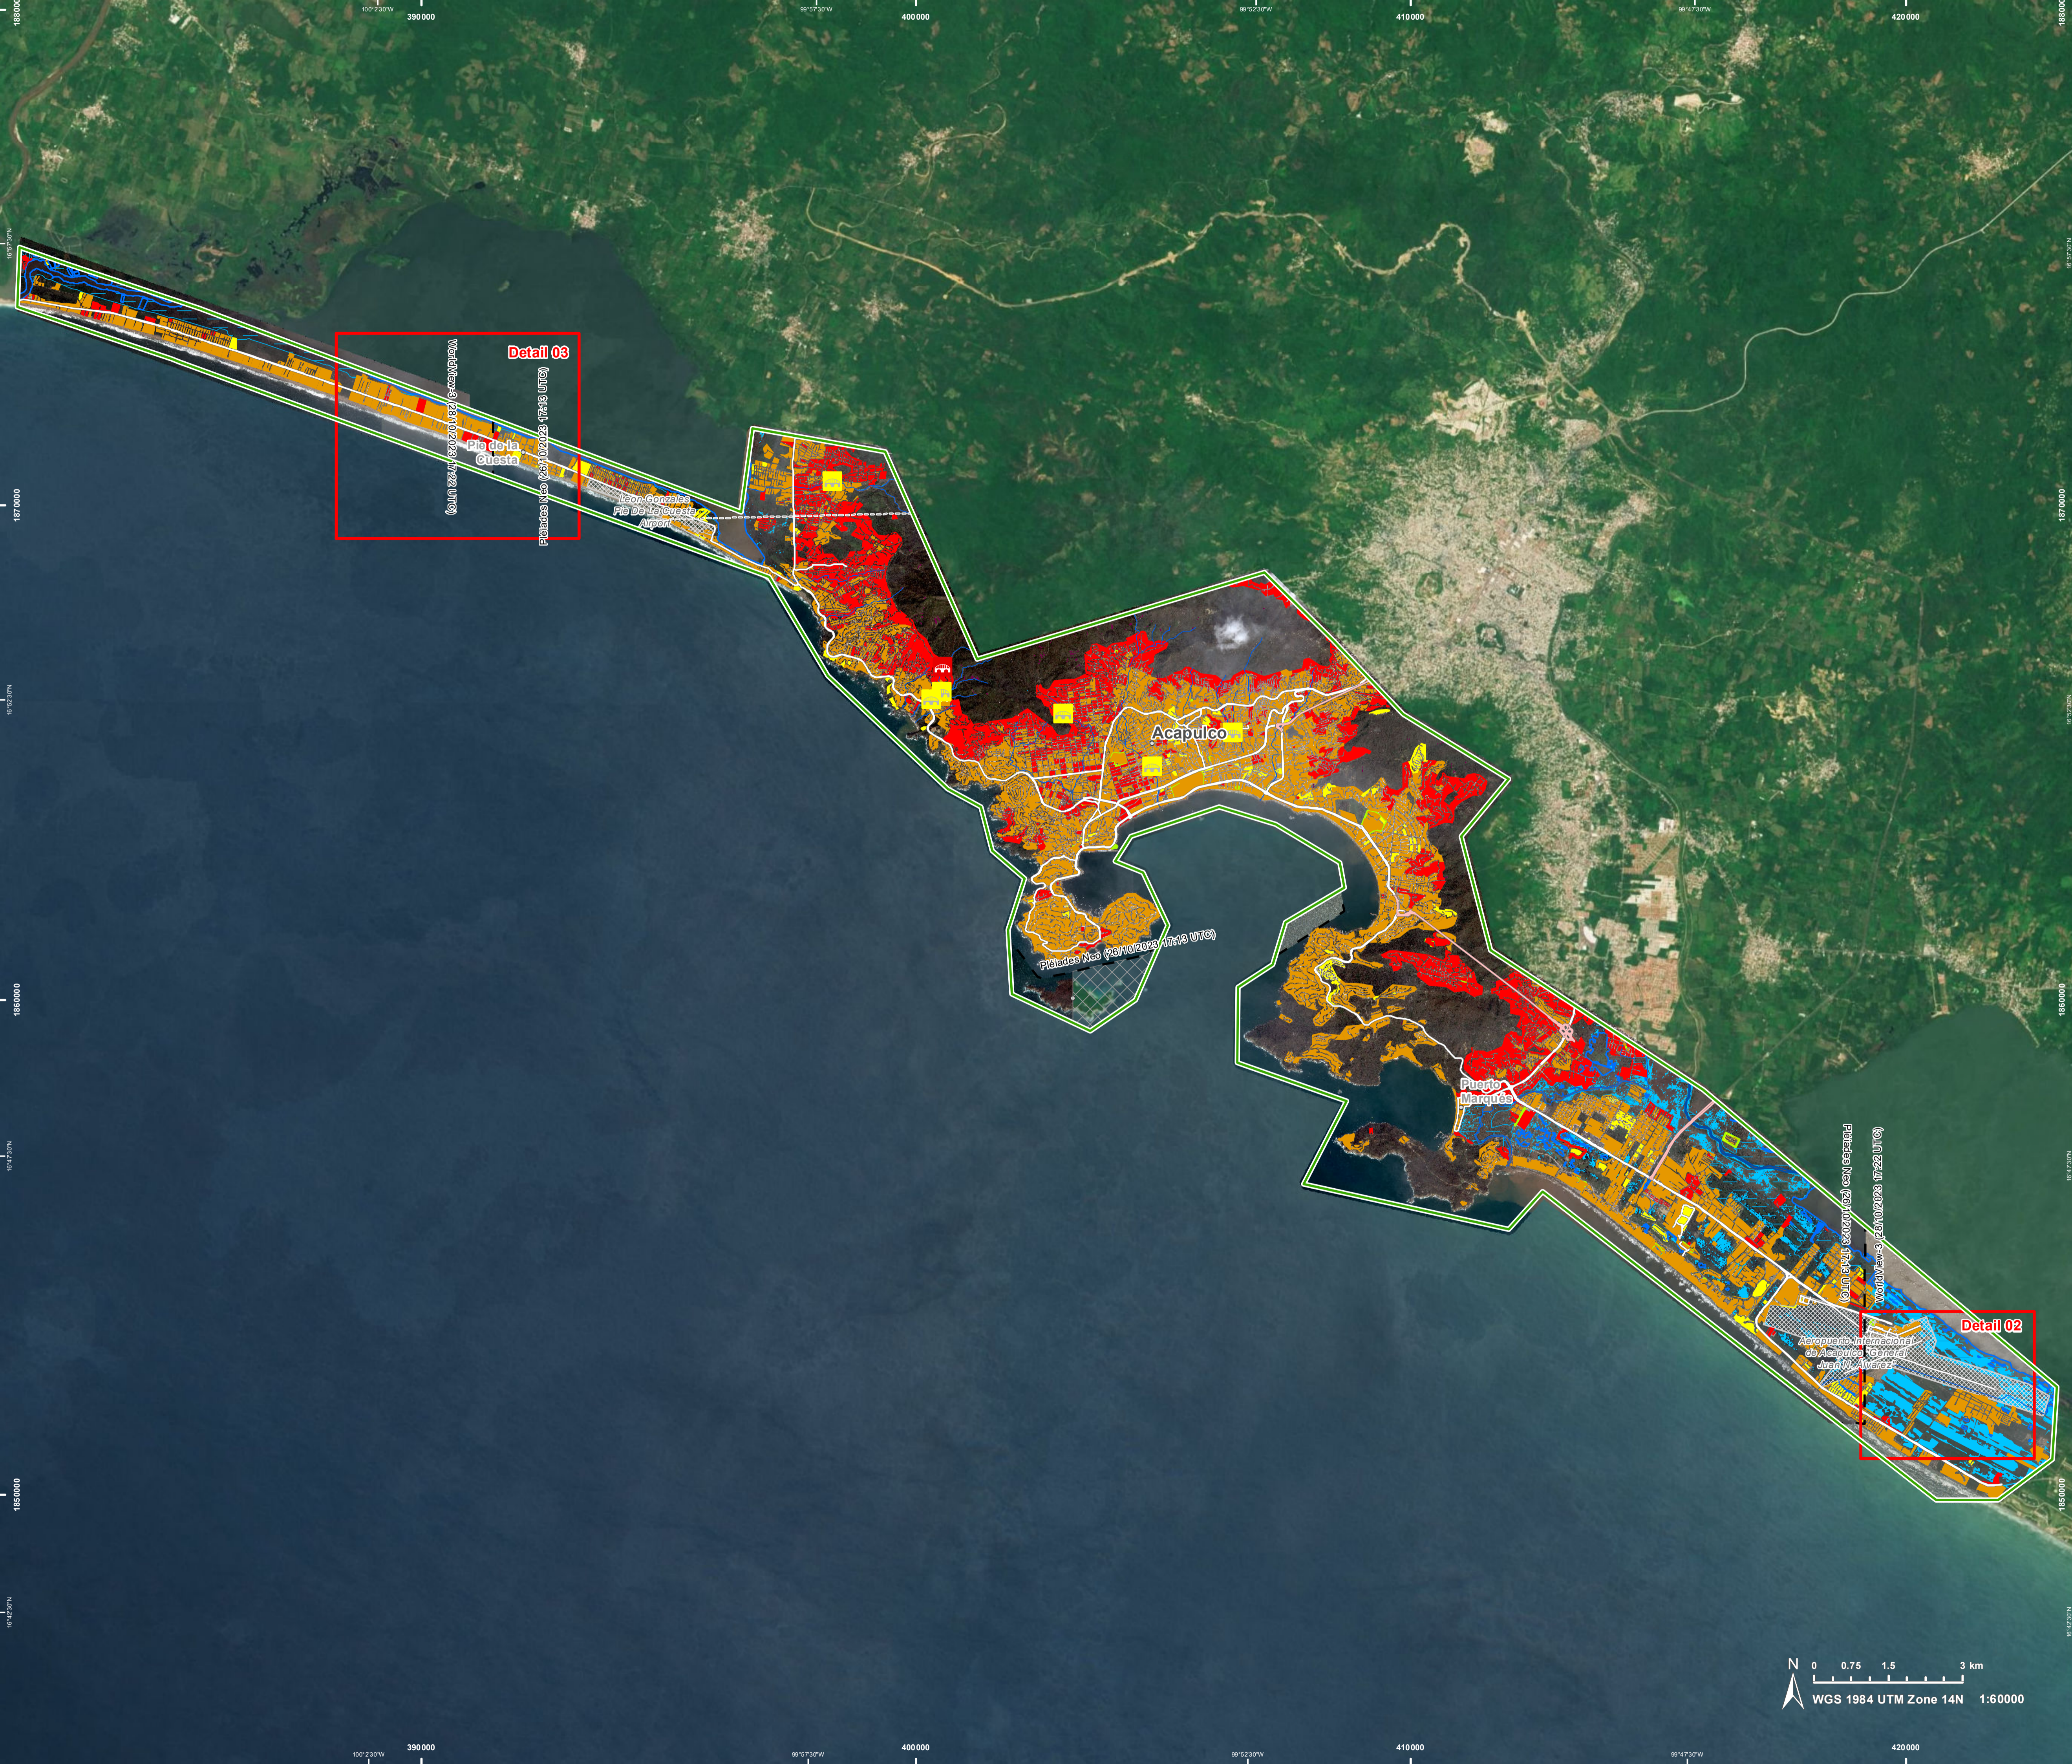
Affected Built-up and Transportations

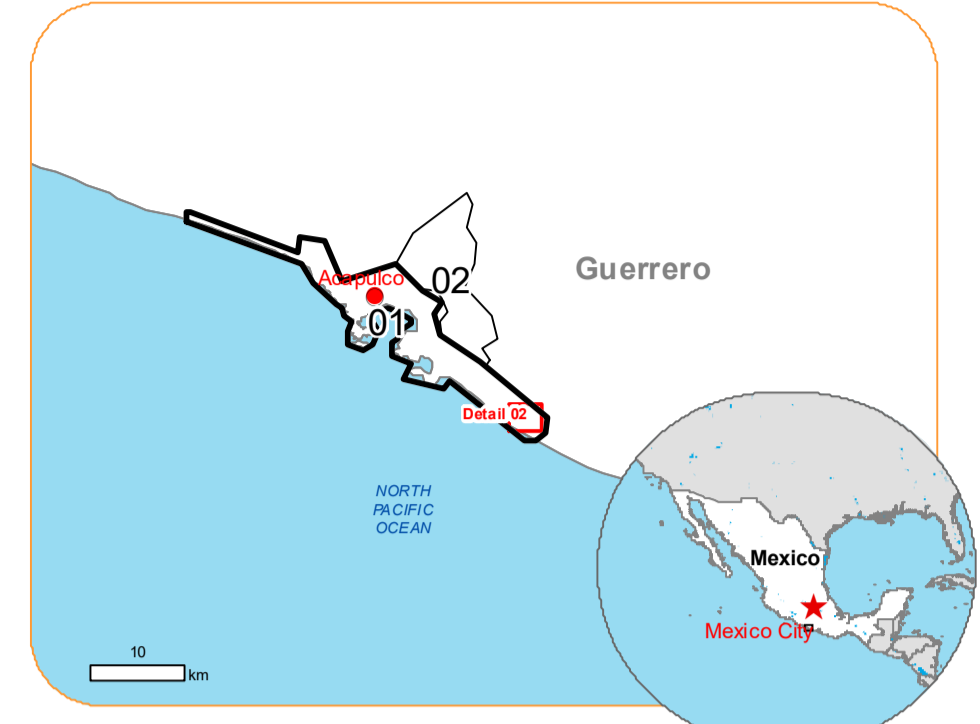
Situation as of 28/10/2023 17:23 UTC
Grading MONIT01 - Detail map 02

Flooded area 263 ha (45 % of total affected)
 Potentially affected population ~ 3,400 (0.9 % of total affected)

Road 3 km (11 % of total affected)
 Built-up 111.8 ha (2.4 % of total affected)

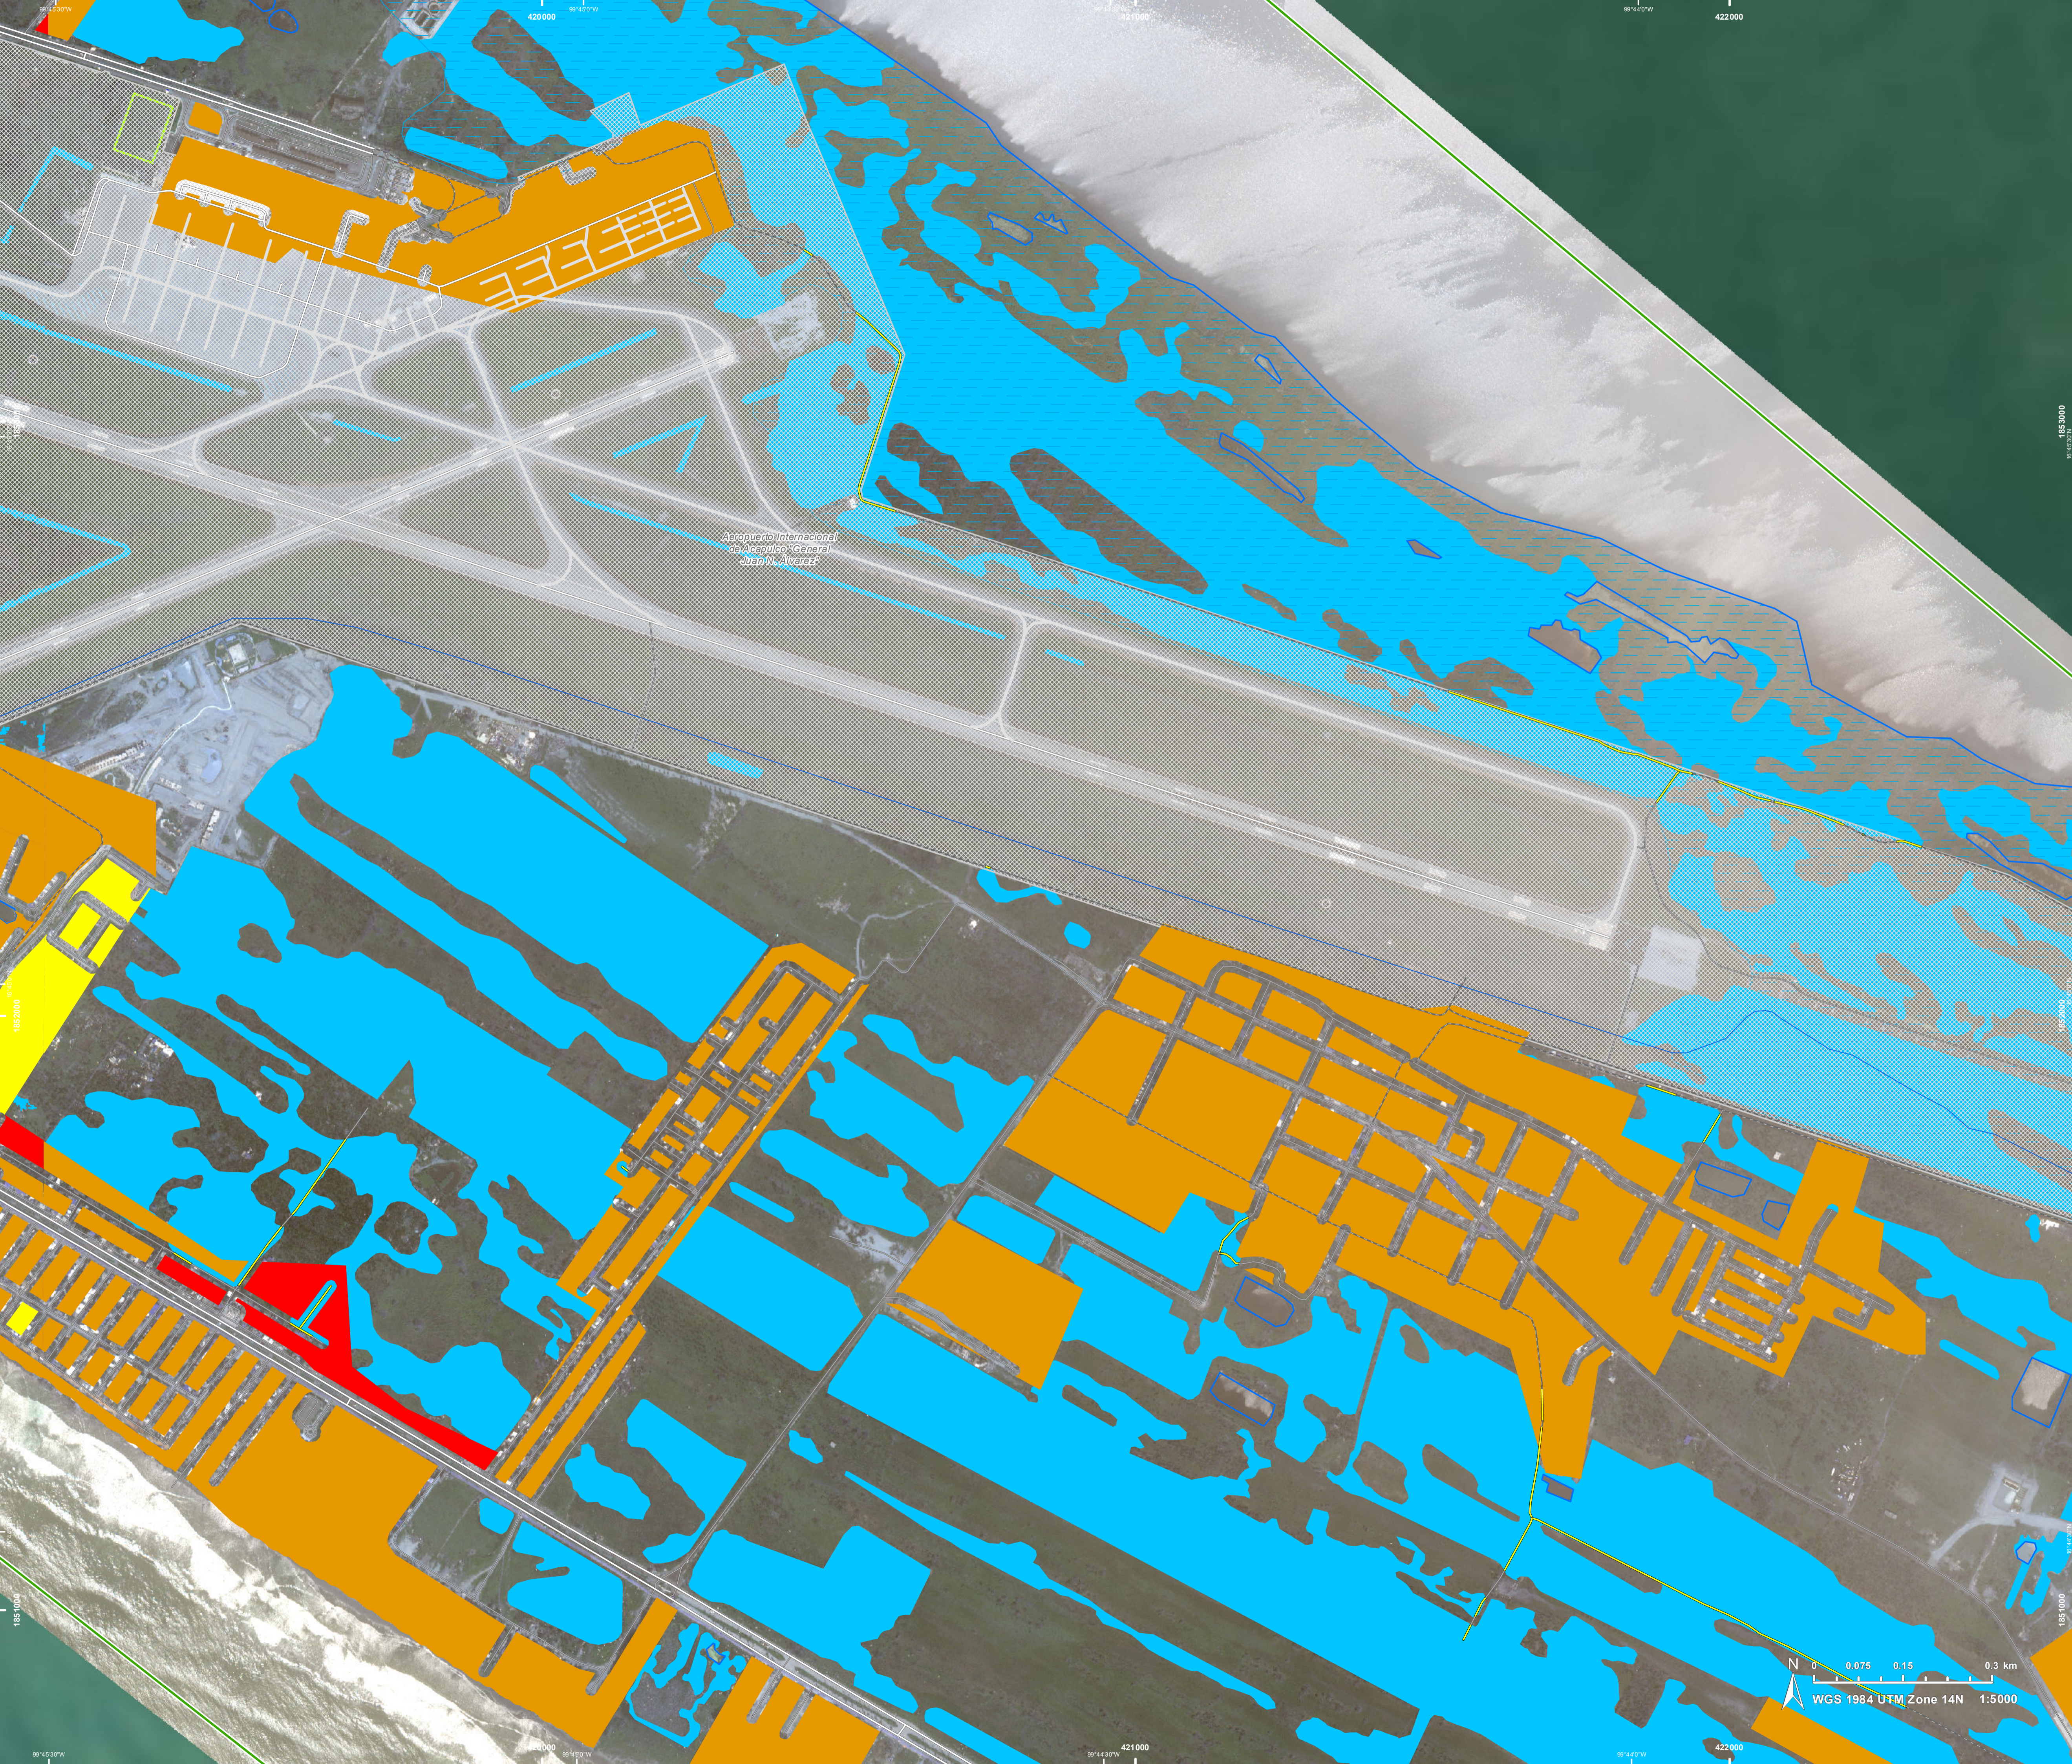
Affected Built-up and Transports

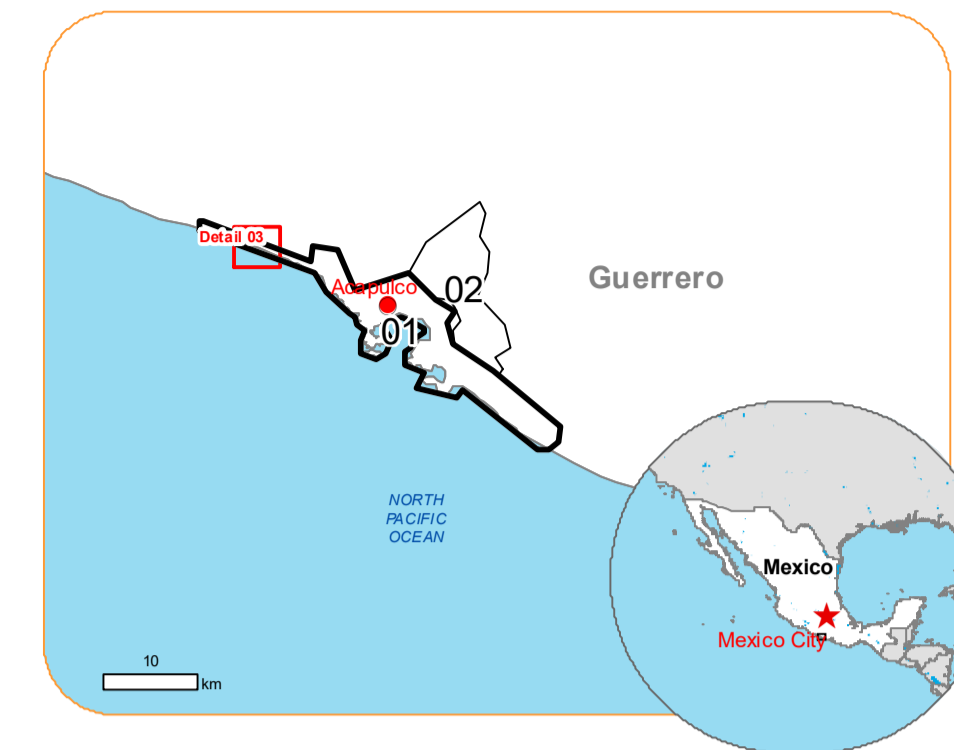
Situation as of 28/10/2023 17:23 UTC
Grading MONIT01 - Detail map 03

Flooded area 0.052 ha (~0.01% of total affected)
Potentially affected population ~2141 (0.5% of total affected)

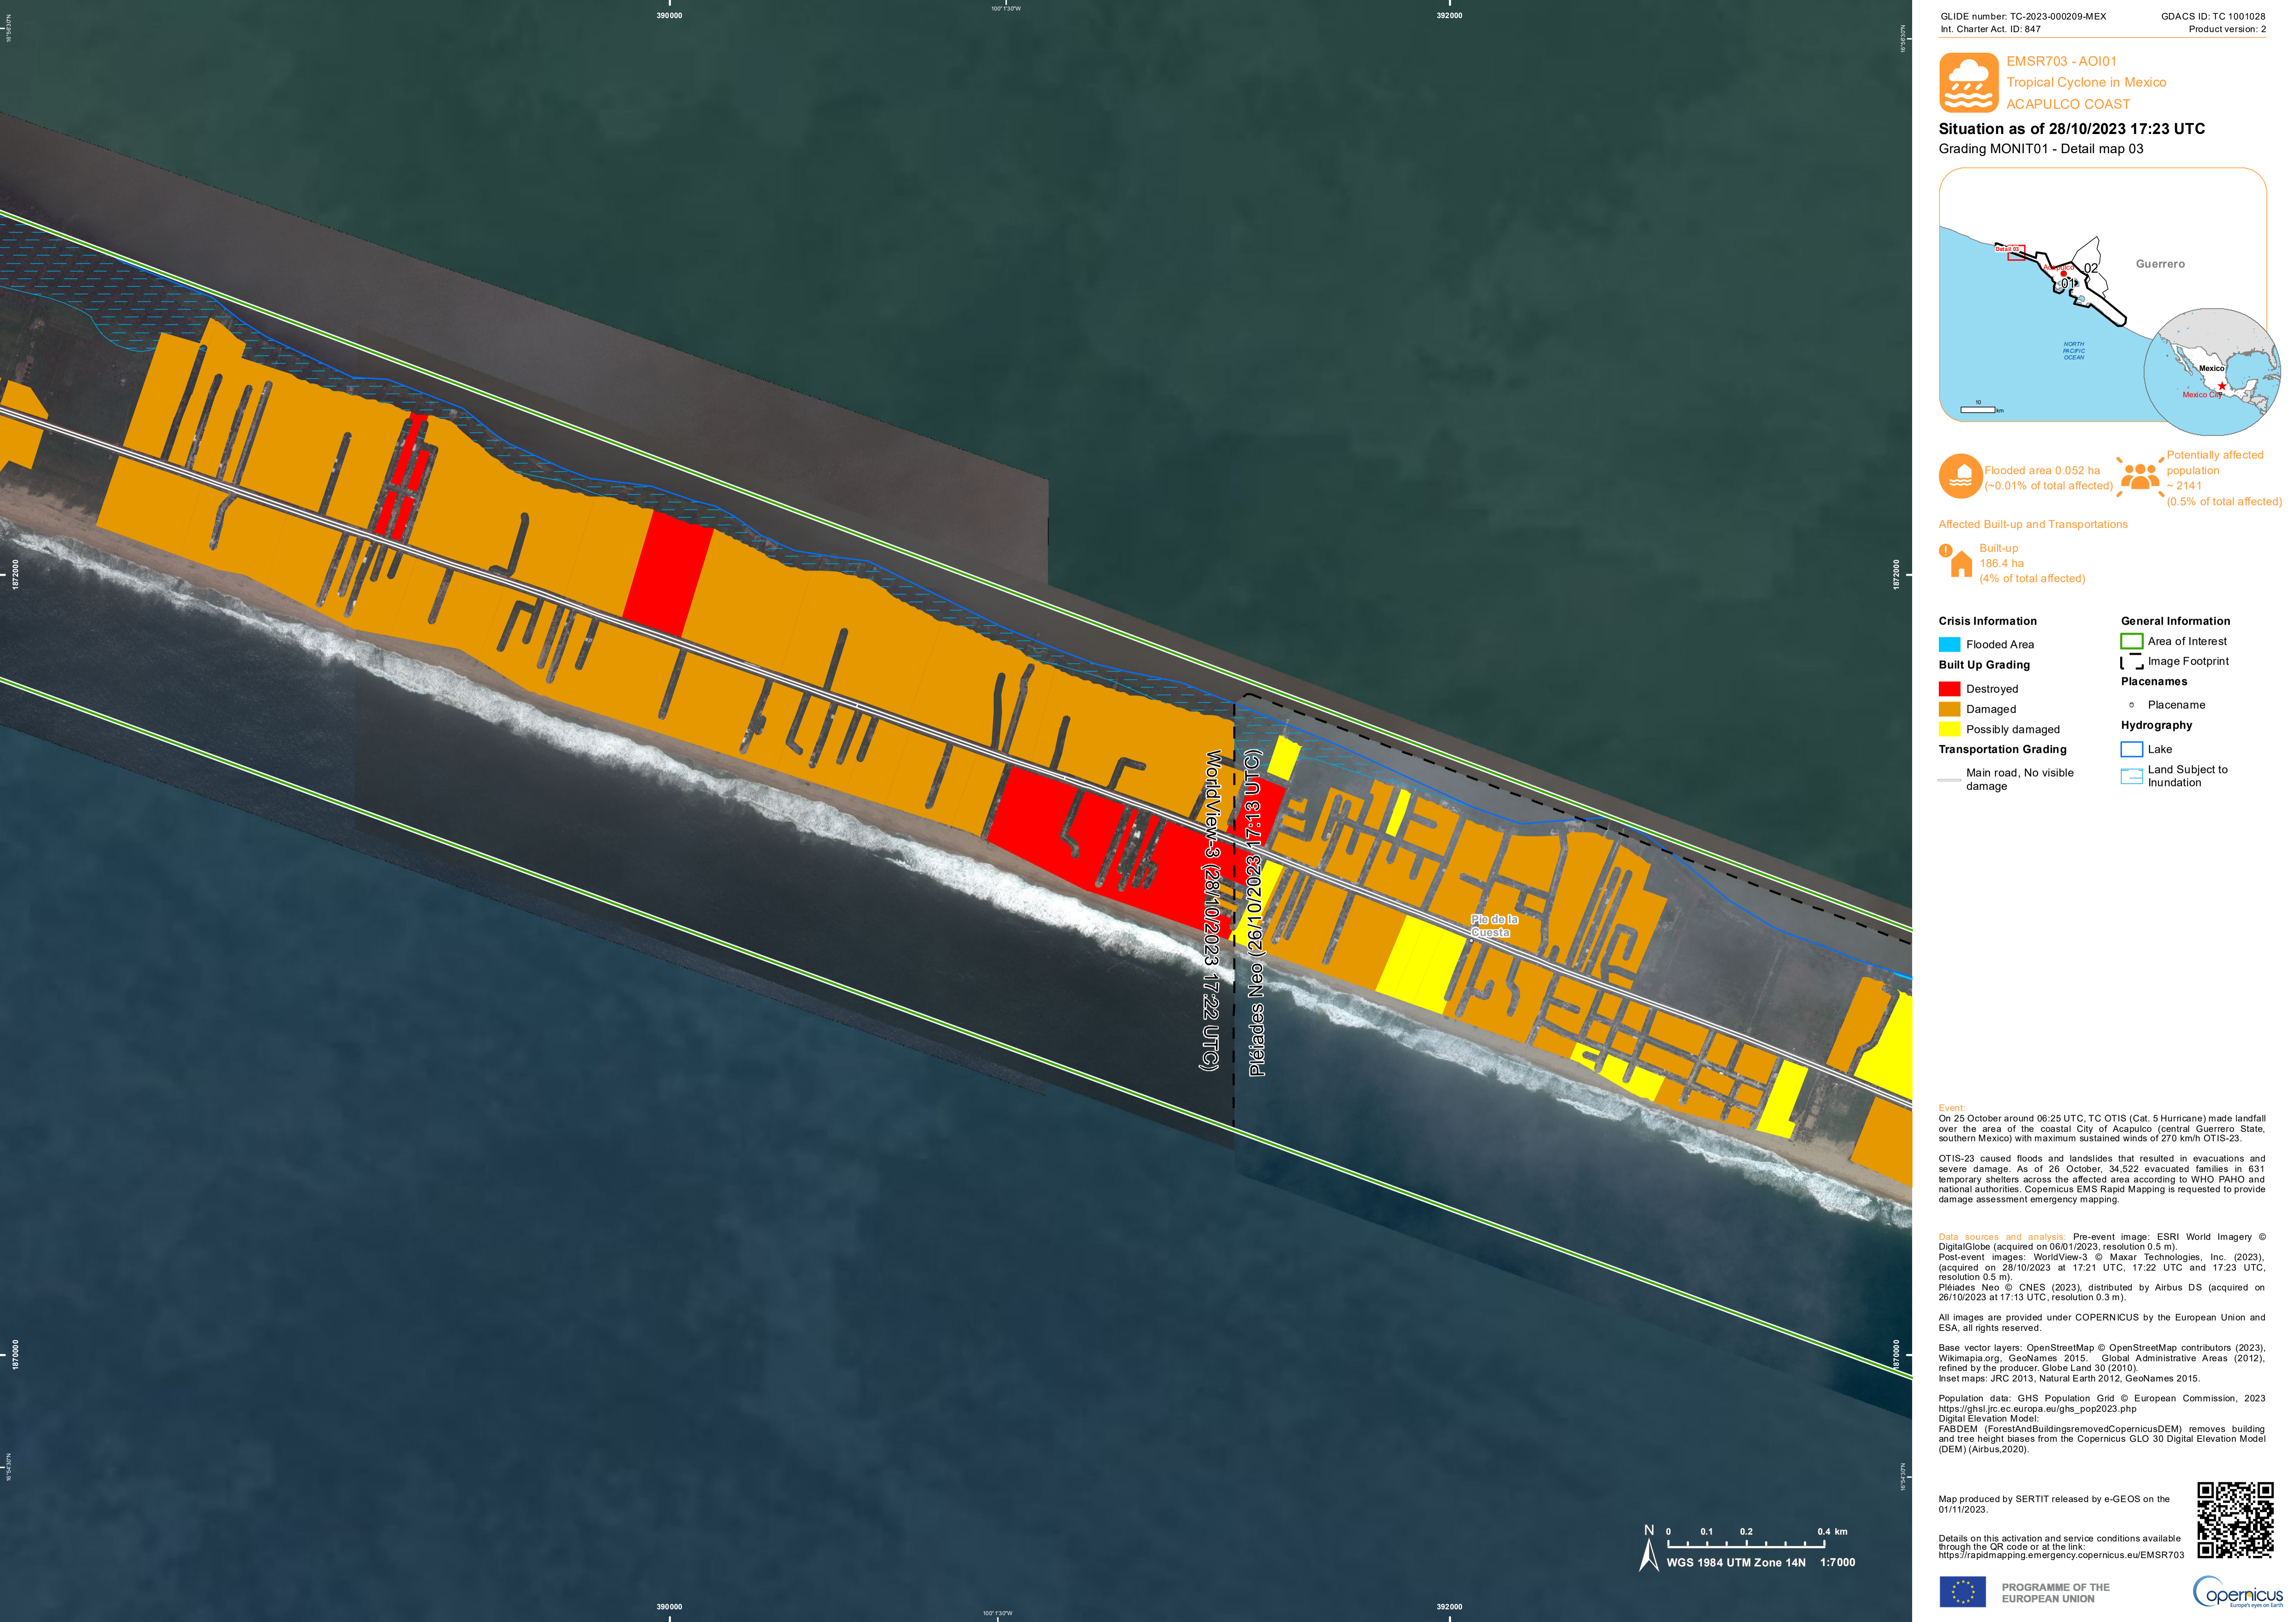
Affected Built-up and Transportations

Built-up 186.4 ha (4% of total affected)
