Automated Landslide/Debris Flow Detection (GFZ)

Map shows landslides and debris flows triggered by locally heavy rainfall in Mocoa, Putumayo, Colombia on 1 April 2017. Remote sensing-based detection was performed by an automated landslide mapping approach developed at Remote Sensing Section of GFZ Potsdam (Behling et al. 2014, 2016). Satellite imagery was acquired by the RapidEye system and provided by Planet Labs Germany GmbH and DLR-RESA program. Before-image: 21 November 2013, After-image: 10 April 2017 (background image of map). Map depicts in red the more than 600 automatically detected landslides and debris flows that occurred in the three watersheds west of Mocoa draining east to the flood plain where the town is situated. Thus, large volumes of debris originating from spa-

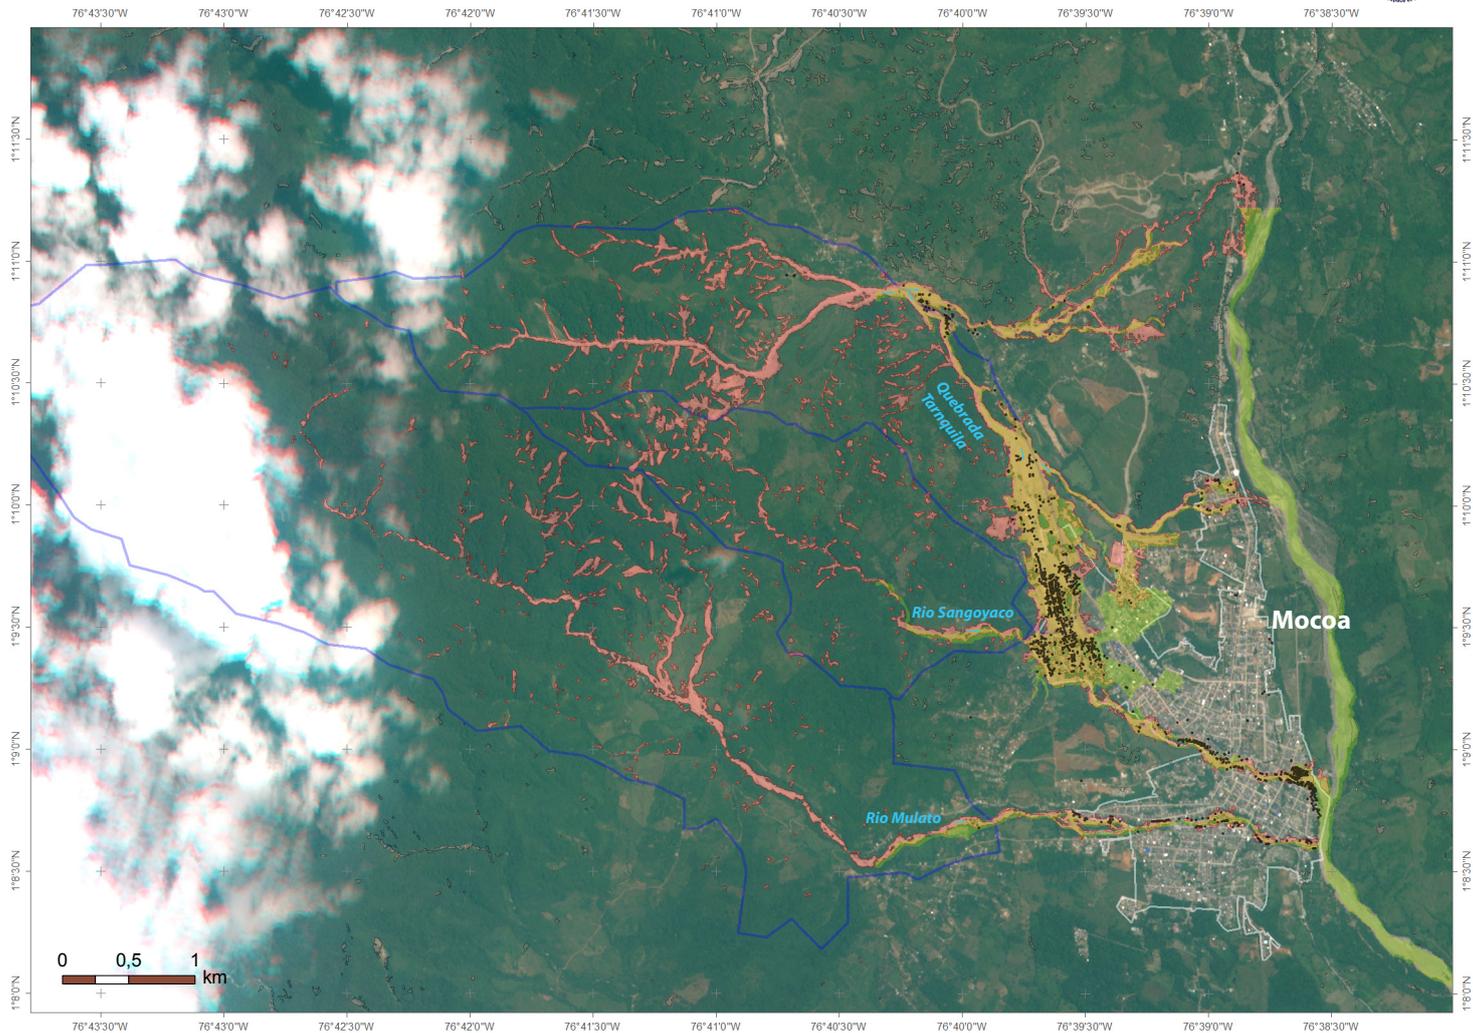
tially distributed sources created the terminal flash flood that caused the disastrous impact on Mocoa. Remote sensing-based flow mapping also shows that part of the flood was diverted to the east before entering town (bifurcation depicted by cyan arrows) possibly preventing an even bigger disaster. Detected landslides and debris flows are shown in combination with results of rapid damage and flood mapping carried out by UNITAR/UNOSAT in the frame of the Disaster Charter activation ID: 524.
